# Final Habitat Improvement Plan *revised*

## Teton County Trash and Transfer Station Horsethief Canyon

January 7, 2019  
December 21, 2018 (original)

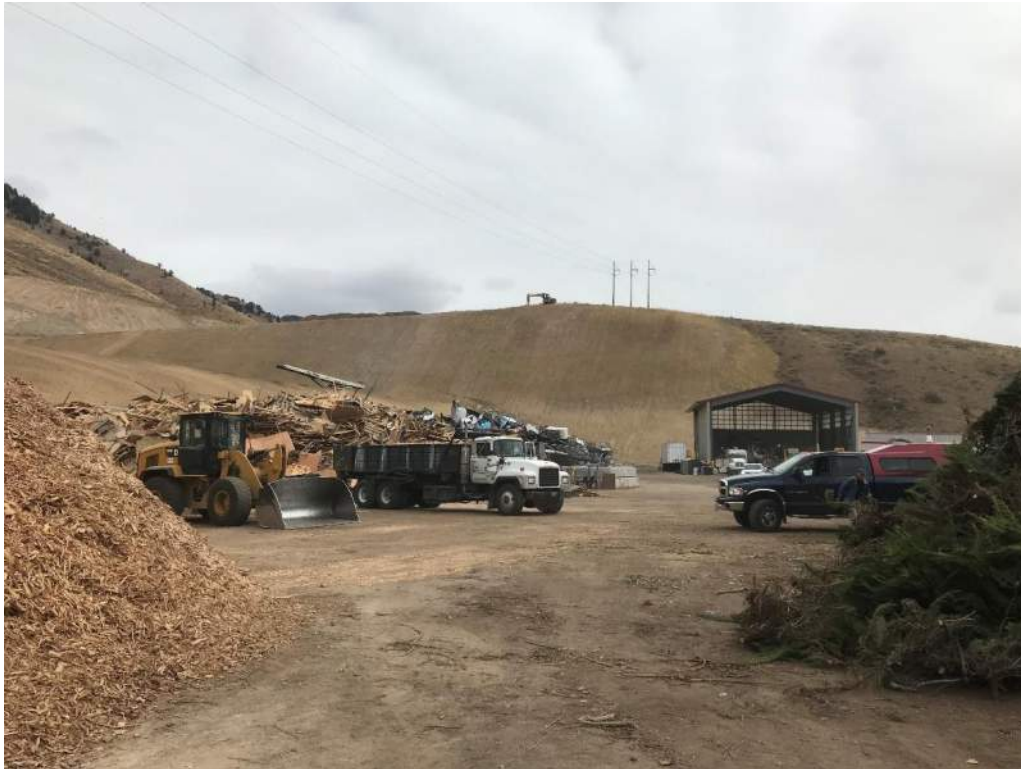
**Photo 1.** Enhancement area between Pad 1 and 3.

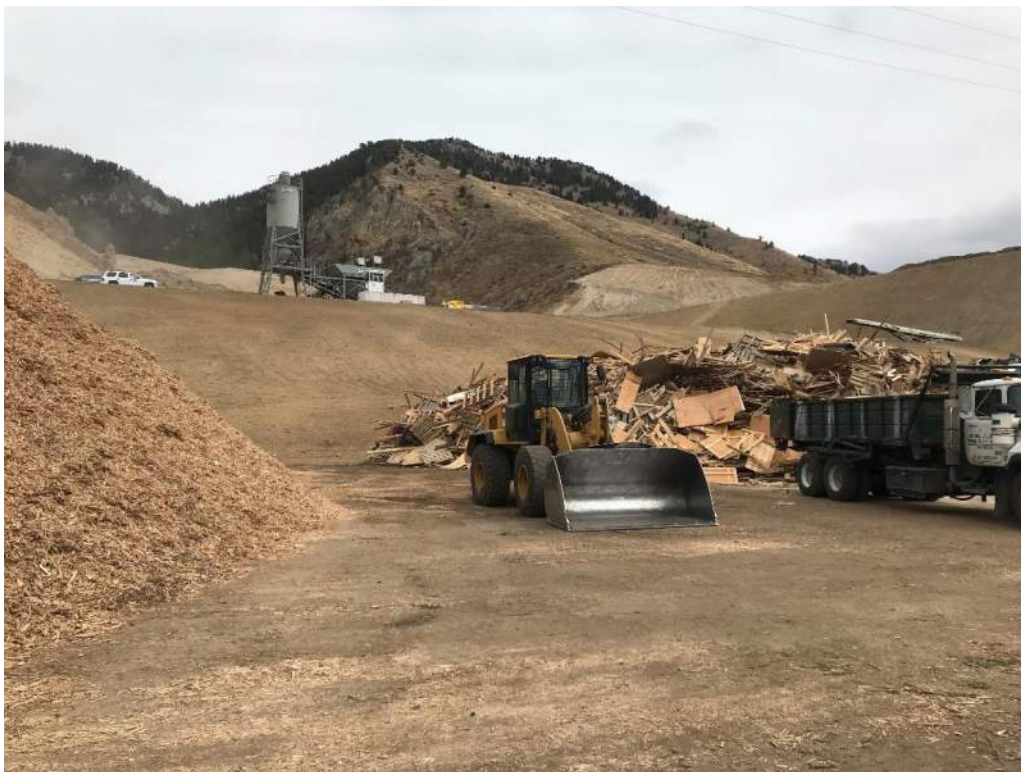
**Photo 2.** Enhancement area between Pad 2 and 3.

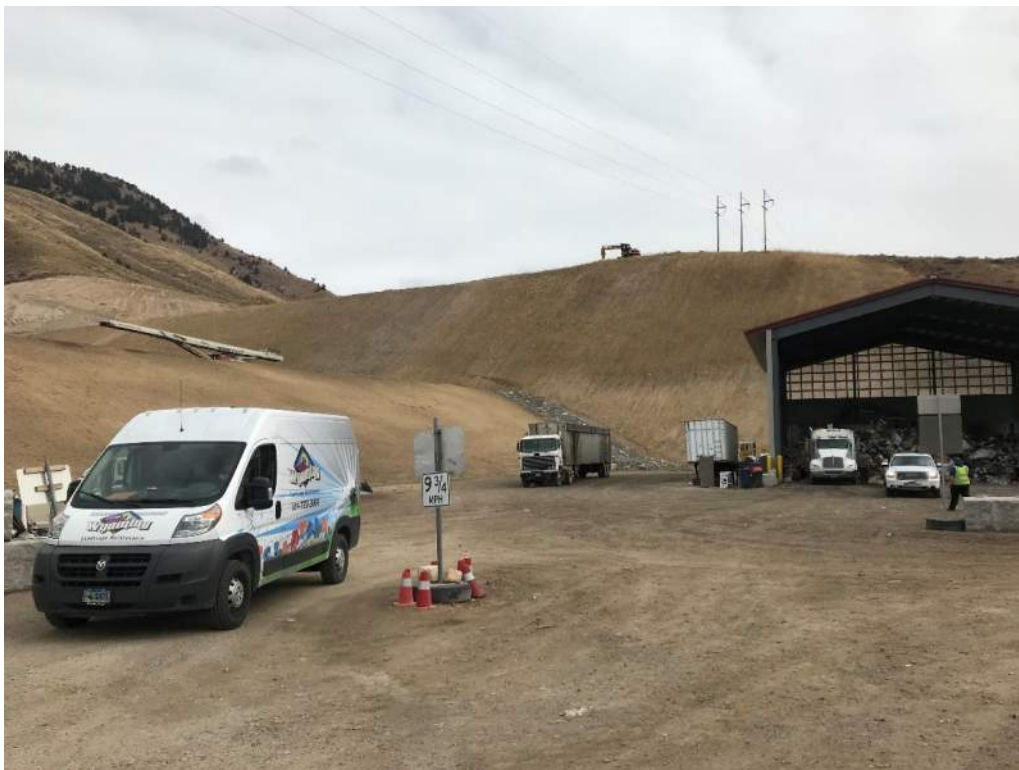
**Photo 4.** Enhancement areas between Pads 1 and 3 (below power lines) and Pads 1 and 2 (to the left).

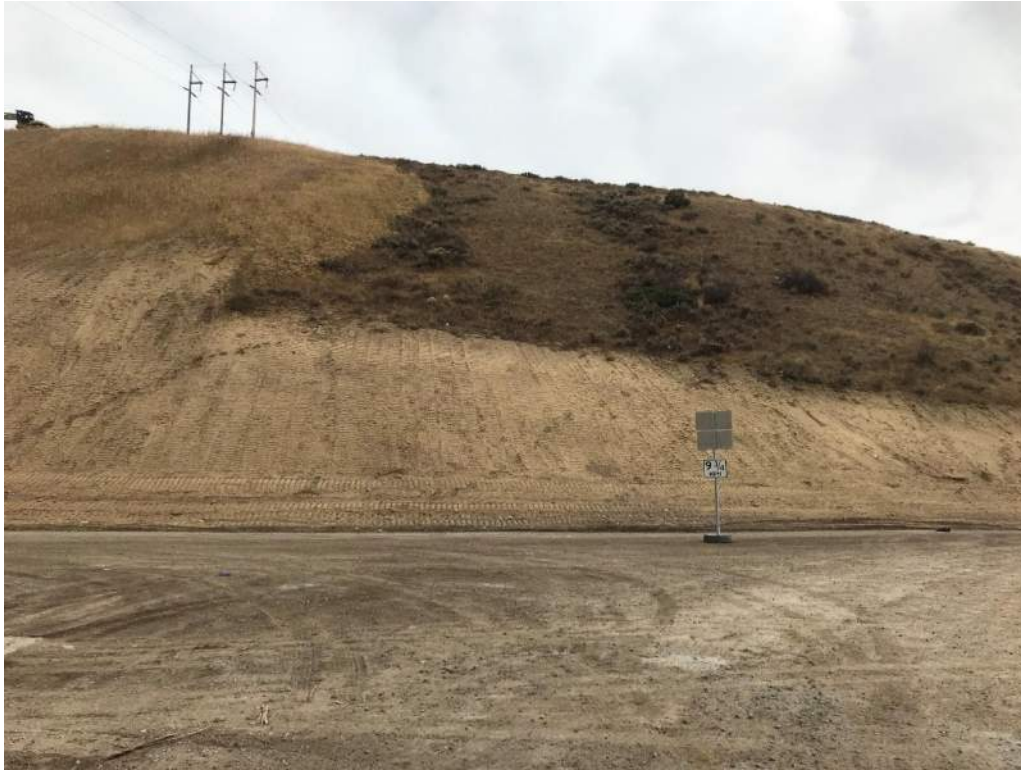
**Photo 5.** Slope displaying seeding for slope stabilization (left), natural sagebrush patterns (right top) and recent grading (bottom).

imagery (Greenwood Mapping, Inc, 2018) indicates that areas mapped as sagebrush and mixed sagebrush in 2015 (2013 Teton County Aerial Imagery) contained a mix of grasses and a pattern of clustered shrubs likely in areas that retained moisture and snow. This pattern of grasses and shrubs is typical throughout the arid west as well as on the hillsides adjacent to the property (Photos 5 & 9).

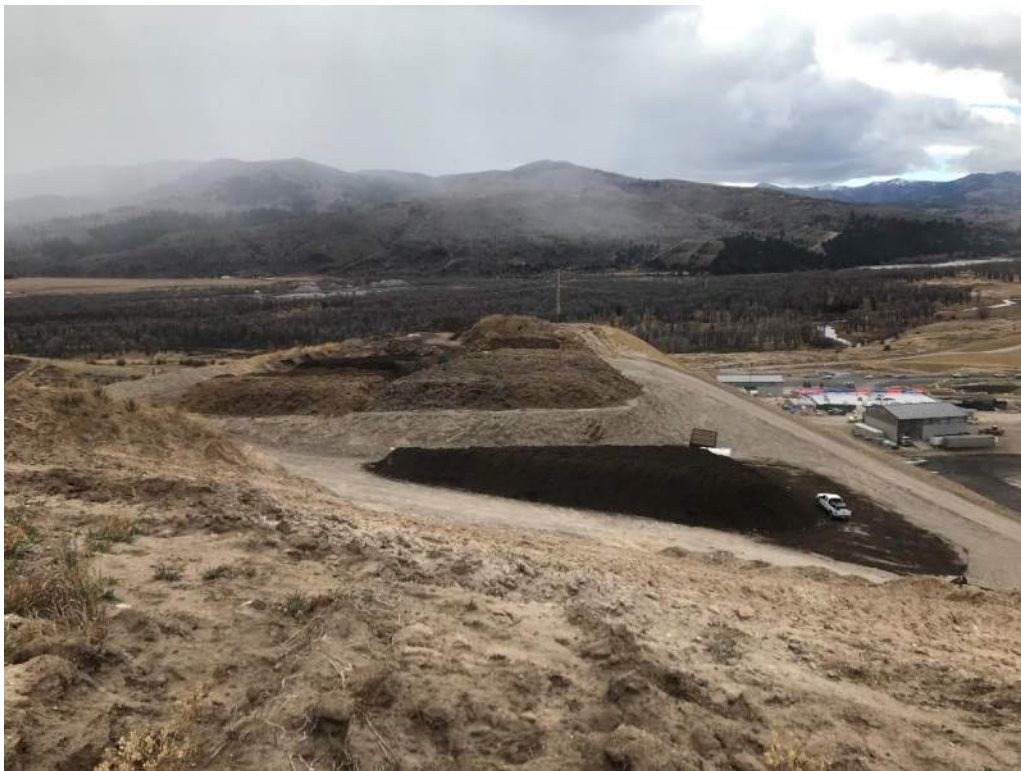
**Photo 6.** Pad 3 organic material processing

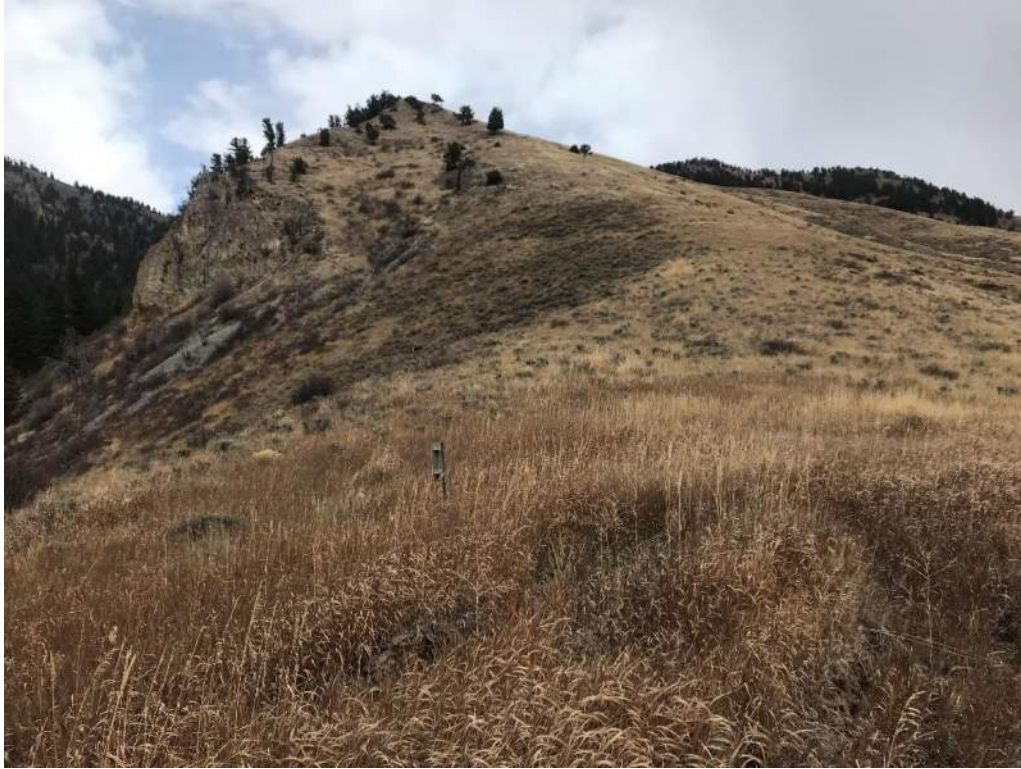
**Photo 9.** Example adjacent mixed tall shrub, sagebrush and grassland cover type matrix

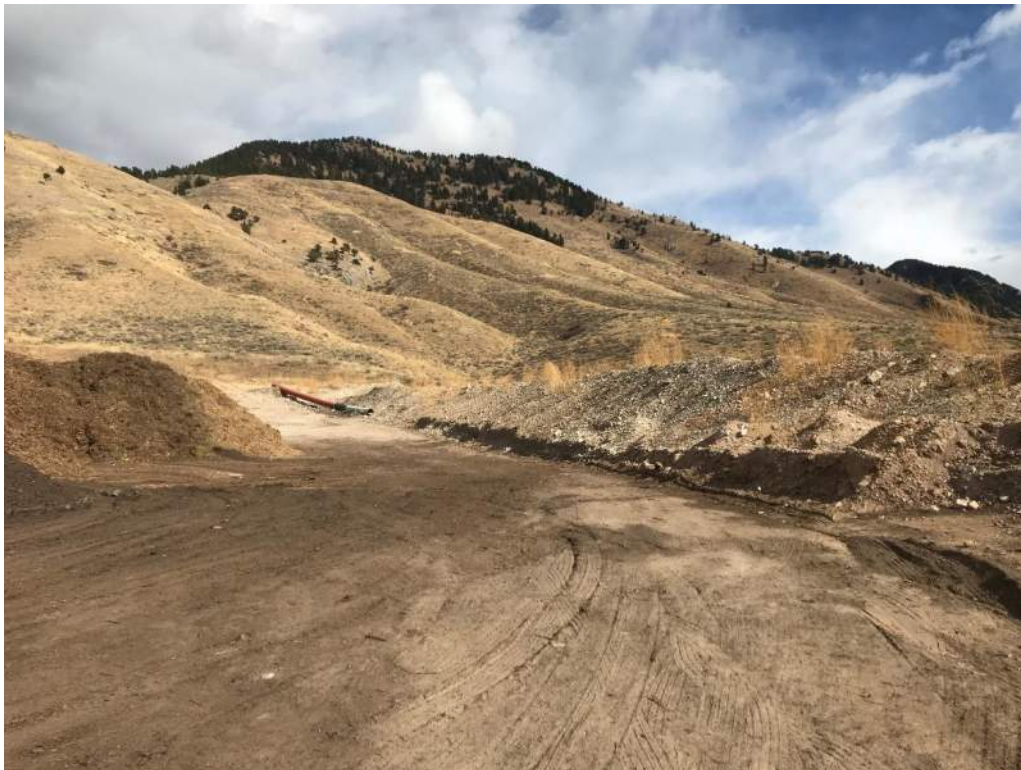
**Photo 10.** Pad 3 berm stockpiles where it will blend into hillside

Enhancement and revegetation locations were determined based on aspect and potential use of the property by ungulates. No permanent exterior fencing is proposed for the property therefore, mixed tall shrub enhancement areas are proposed on the exterior of the facilities areas. Mixed tall shrub species provide excellent forage to ungulate species and can serve as an attractant to ungulates. Ungulates likely pass through the property following north-south ridgelines on both the eastern and western edges of the property. Therefore, mixed tall shrub enhancements have been placed on the exterior of the operations area, along a ridgeline, in an effort to avoid attracting ungulates into the property's operational areas. Sagebrush and grass areas were placed to align with adjacent sagebrush areas, revegetation of the USFS project area, to aid with slope stabilization efforts and along a berm constructed to protect the upper most operational pad (Pad 3) from the WGFD shooting range activities.
